All done bar the shouting

BY LYNDA WILSON

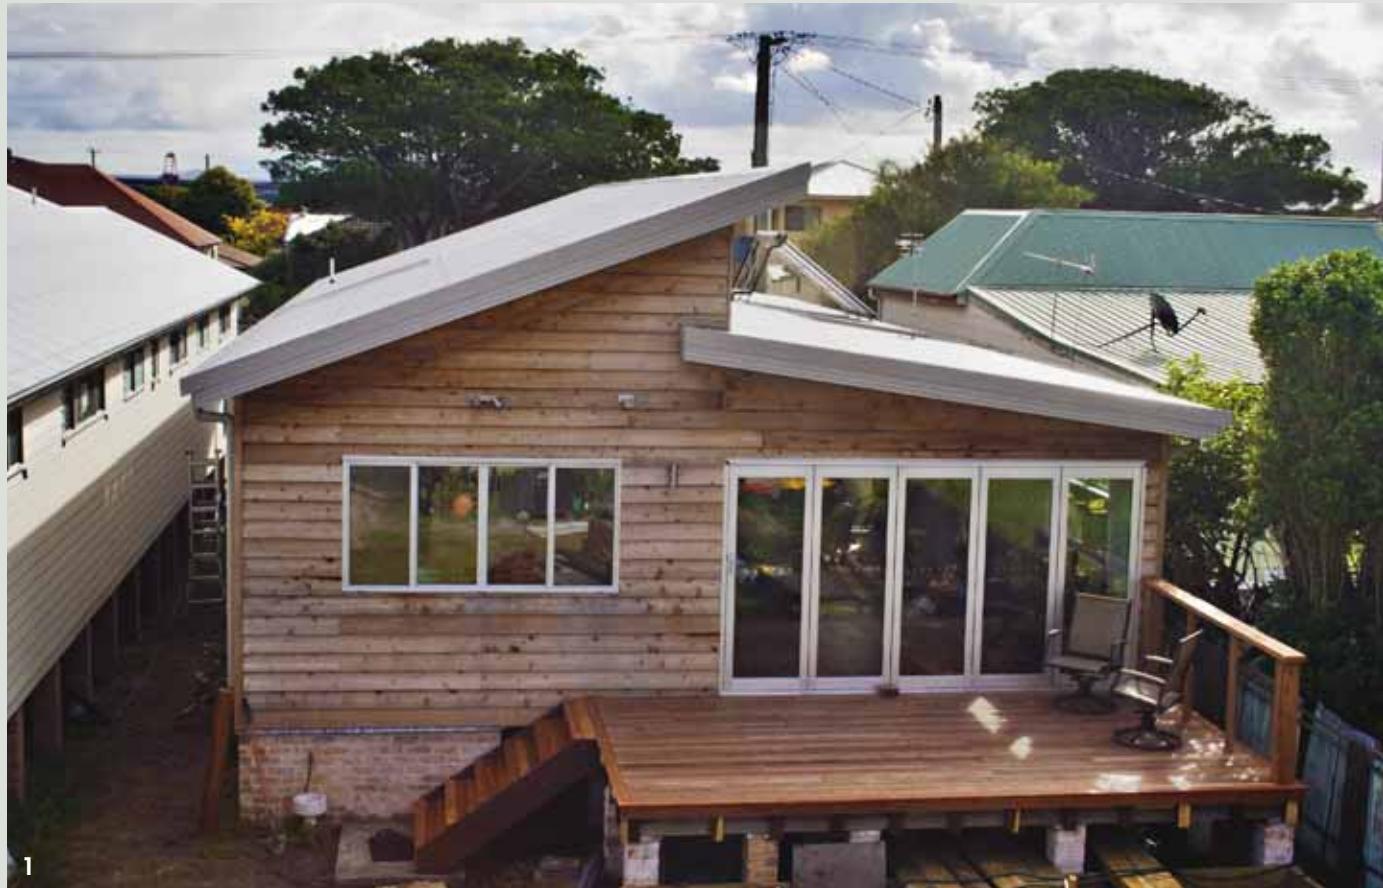
1

1. Rear deck nearly ready for use.
2. Natural light from the clerestory windows floods the living area.
3. Simple and functional kitchen, with large drawers for storage.
4. The first coat of oil being rolled on – the timber begins to shine.
5. Shelving behind sliding robe doors will keep the office tidy.
6. Late afternoon light – natural art in the passage gallery.
7. The rear deck catches morning sunshine and summer breezes, meaning it will be well used.

Decking

In total there is about 55m² of decking. This is being finished with mixed red timbers from the same source as the flooring timbers.

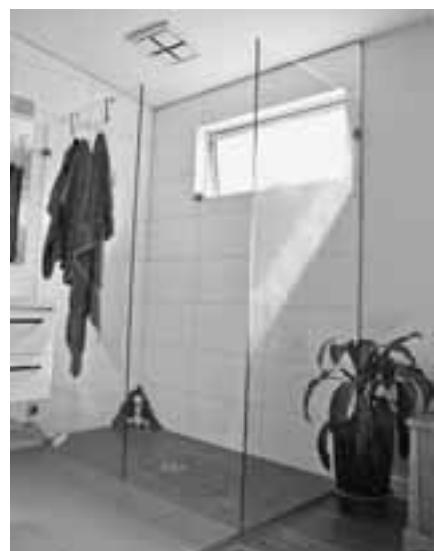
Frameless shower screens in the ensuite give the illusion of a much bigger space.

I love the look (and ease of cleaning) of frameless shower screens, but am not so sure about the sturdiness. The external upper corner of each screen has a fair bit of play when touched, never mind if knocked, so I am considering installing a support bar between the two edges.

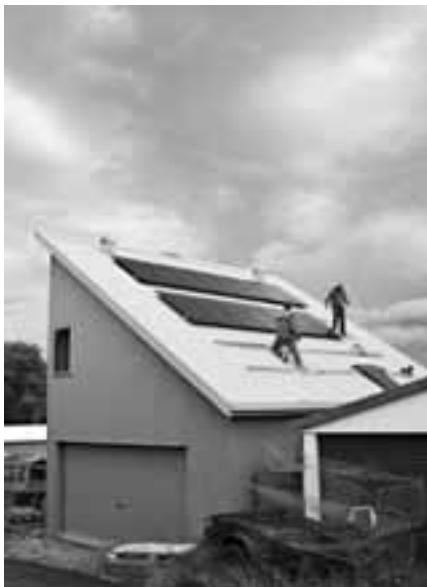
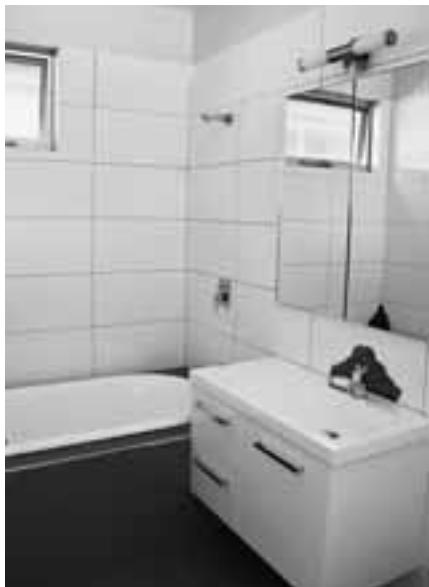
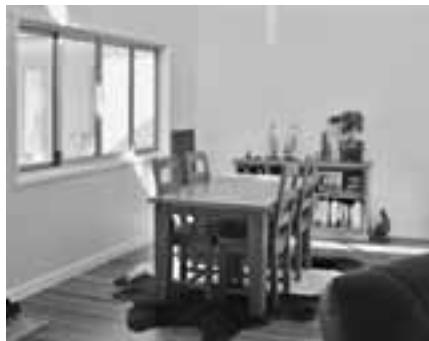
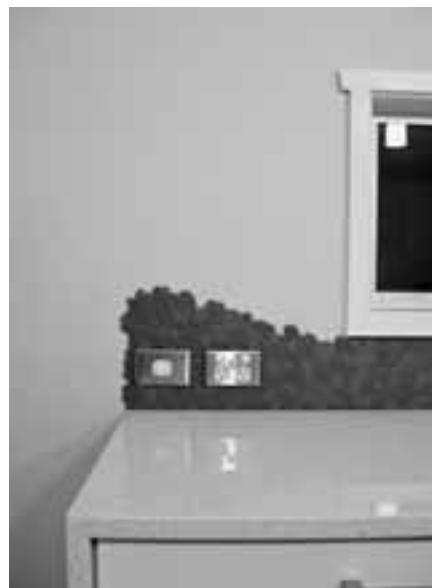
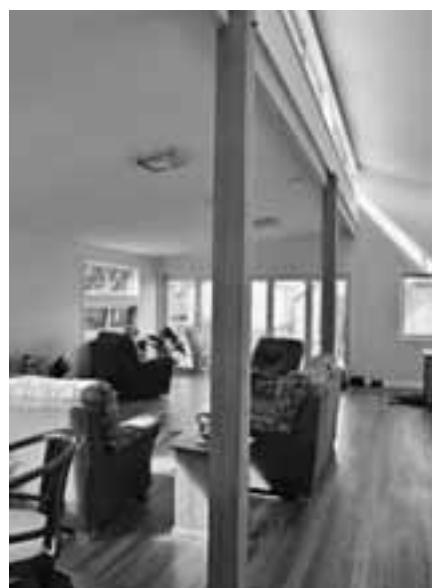
Clockwise from bottom left: Timber floors and recycled ironbark posts add a sense of 'age'; kitchen pebble splashback with arts and crafts inspired architrave; solar panels going up; main bathroom; dining area alongside kitchen.

The greatest excitement was on the day that the solar system was connected. 24 x 185 watt panels provide a 4.4kW system on the garage roof at an angle of 33 degrees. This is the optimum angle for winter sunshine in our area, when the shorter days mean it is imperative to maximise the power generation. The system has been delivering around 23kW on most days. With an expected average of 17.4kW per day over the year, against our average usage of around 8kW, we are more than covering our own power needs.
